Pedestrian Safety Countermeasures Along Delaware's SR 1 Beach Corridor

Roadway Management Conference 2021

Peter Haag, P.E., PTOE
Delaware Department of Transportation
Chief of Traffic Engineering

Kyle Clevenger, P.E., PTOE
Whitman, Requardt & Associates, LLP
Senior Project Engineer

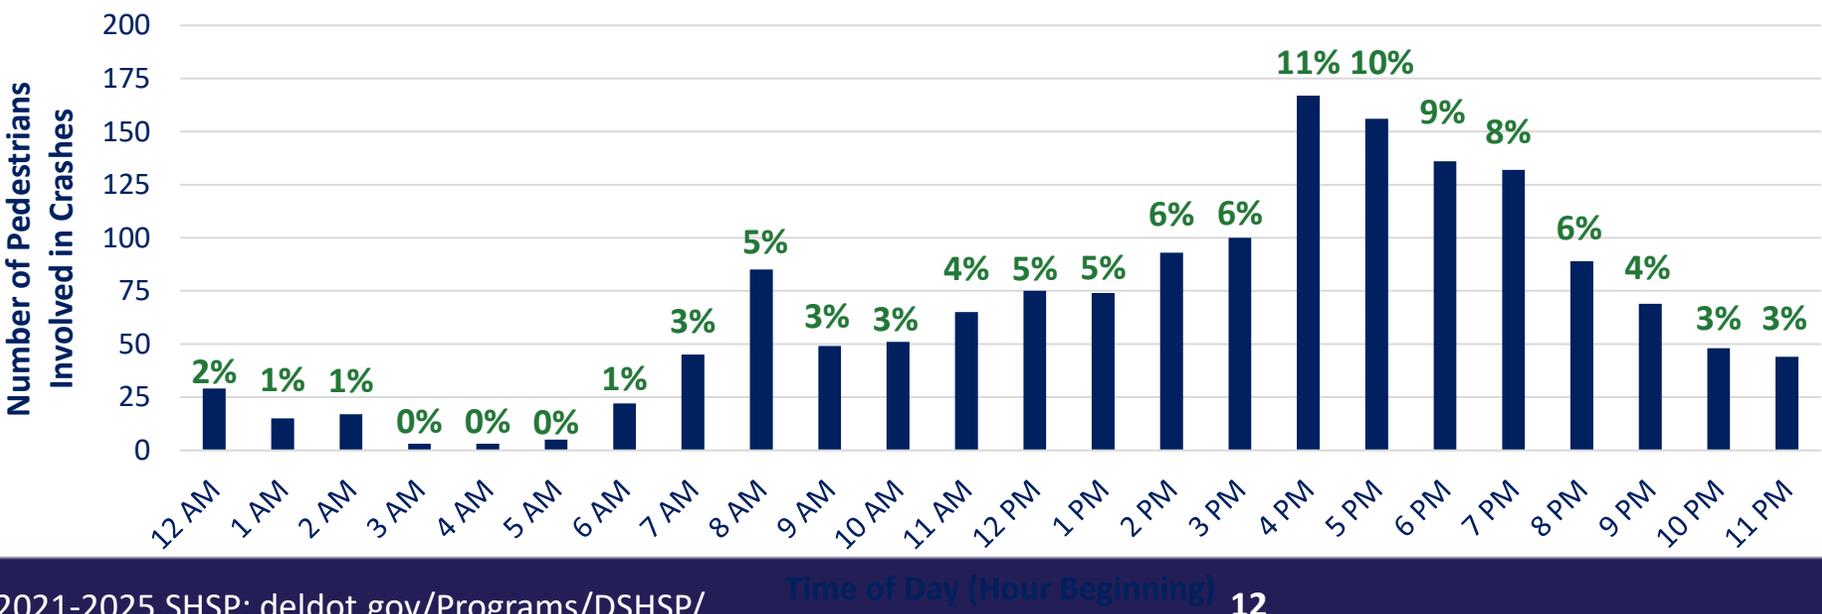
35% of pedestrian fatalities occurred in November, December and January

% of Total Pedestrians Involved in Crashes

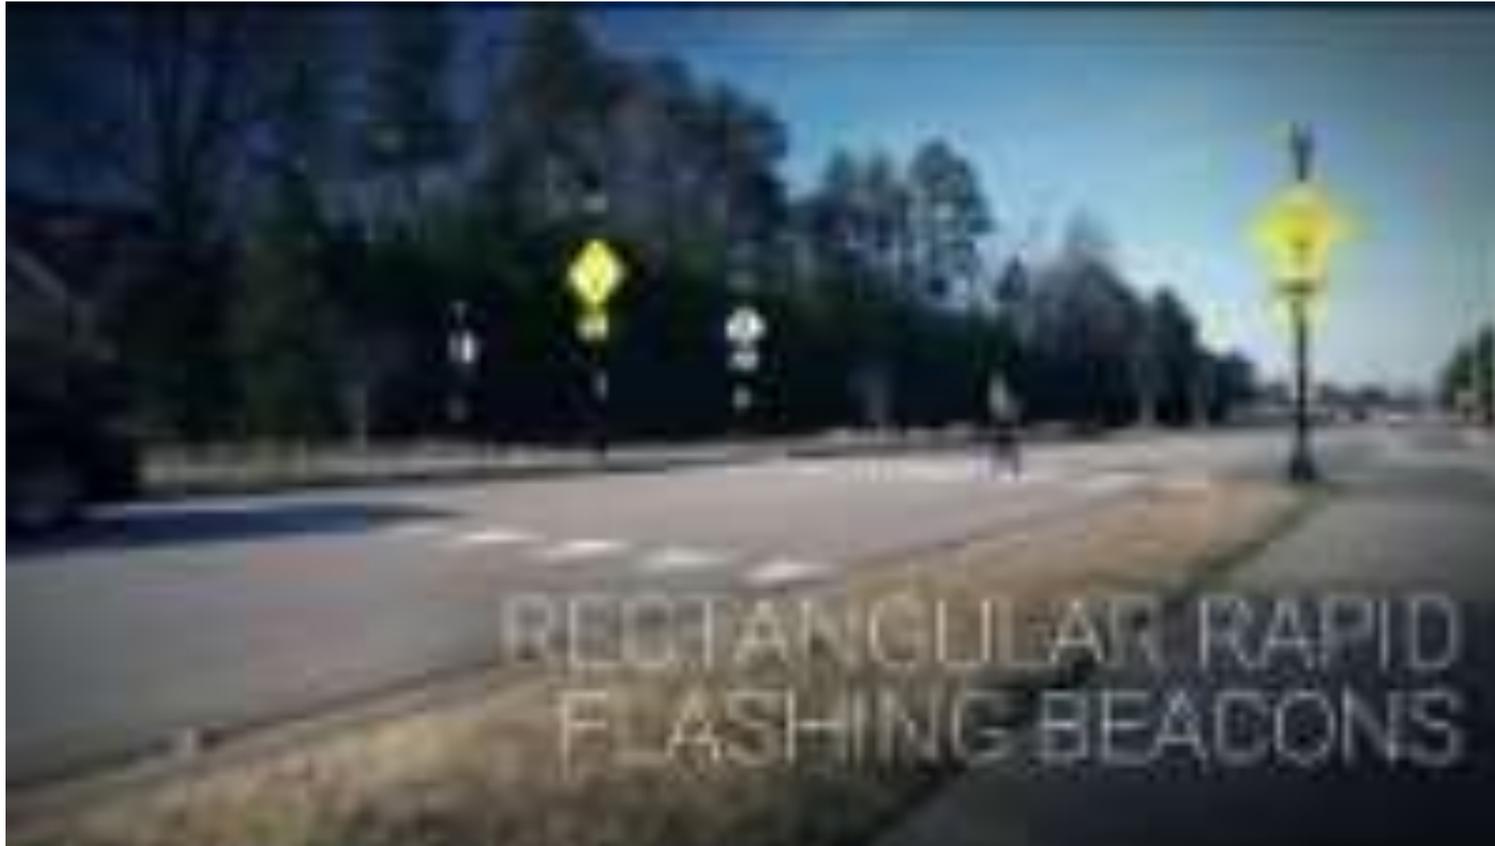
- Rectangular Rapid Flashing Beacons – How do they Operate?

- Rectangular Rapid Flashing Beacon
 - Pedestrian-actuated warning device used at uncontrolled, marked crosswalks
 - Intended to improve compliance with motorists yielding to pedestrians in marked crosswalks
 - First installation in April 2016
 - 43 locations completed since 2016
 - 3 currently under construction
 - 12 planned for future construction
 - 25% average improvement in motorist yielding compliance across all sites

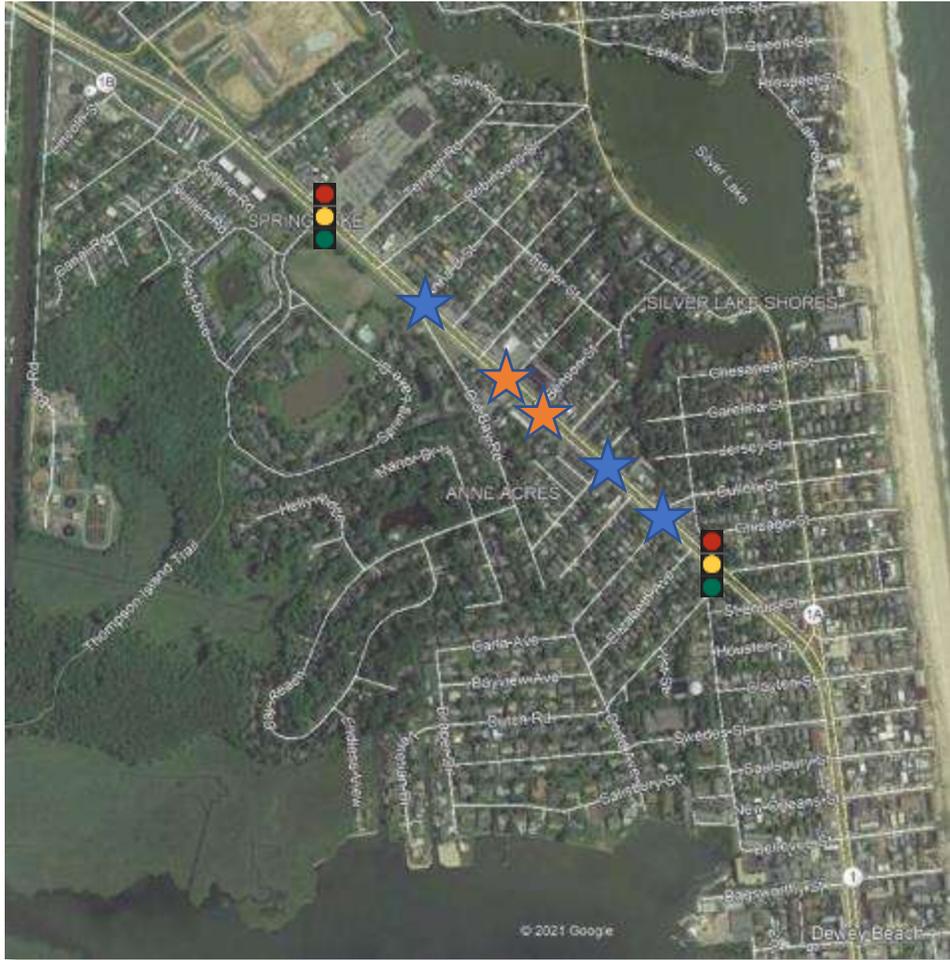
RRFB Locations – SR 1, Rehoboth Canal to Dewey Beach

- ★ RRFB at Existing Crosswalk (3)
 - SR 1 @ Dodd Ave
 - SR 1 @ Ann Ave
 - SR 1 @ Old Bay Rd
- ★ RRFB at New Crosswalk (2)
 - SR 1 @ F Benson St
 - SR 1 @ Joesphine St
- 🚦 Existing Signalized Crosswalk (2)
 - SR 1 @ Bayard Ave
 - SR 1 @ Spring Lake Dr

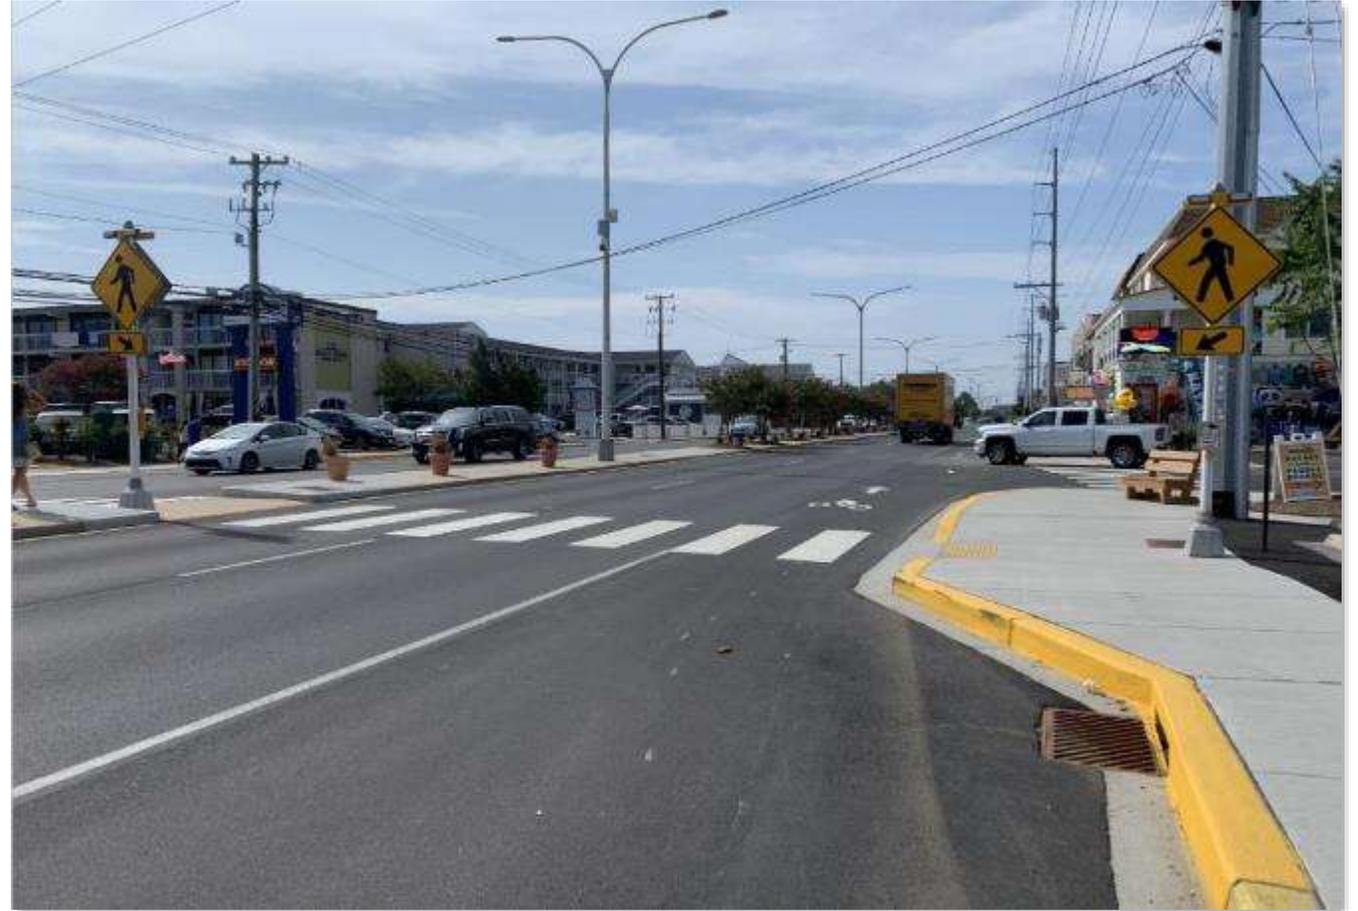
Curb Bumpouts:

- 31 total at 11 intersections
- Reduces pedestrian crossing distances
- Promotes traffic calming and reduces turning speeds
- Eliminates non-compliant pinch points (i.e., utility pole in narrow sidewalk)
- Provides more area for pedestrians at critical crossing areas/conflict points

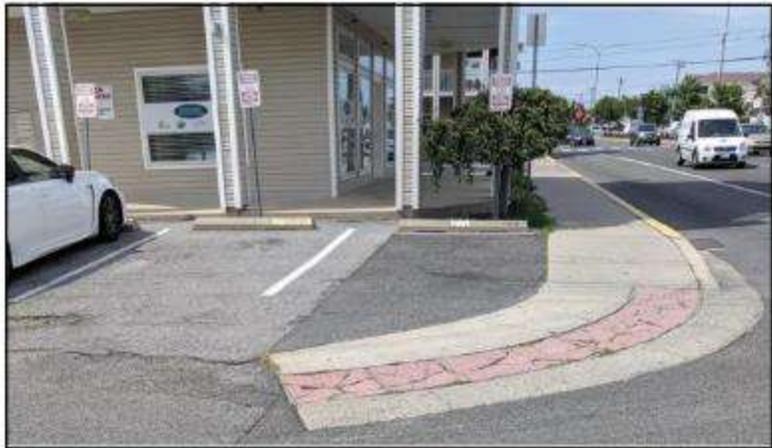
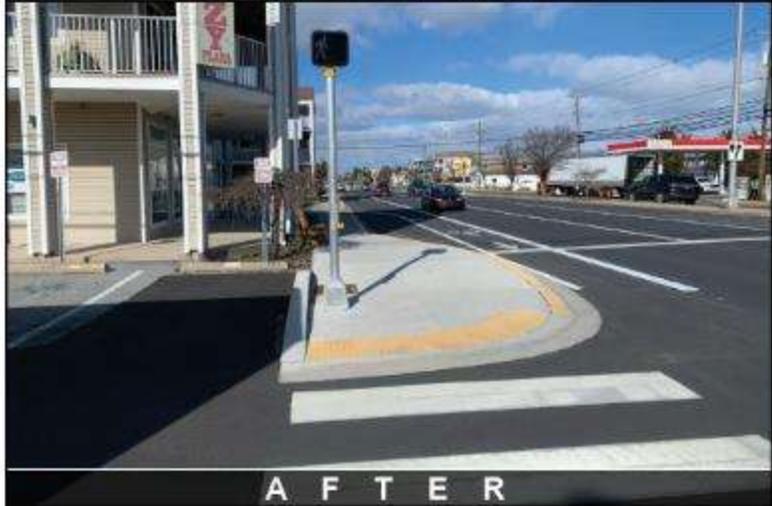
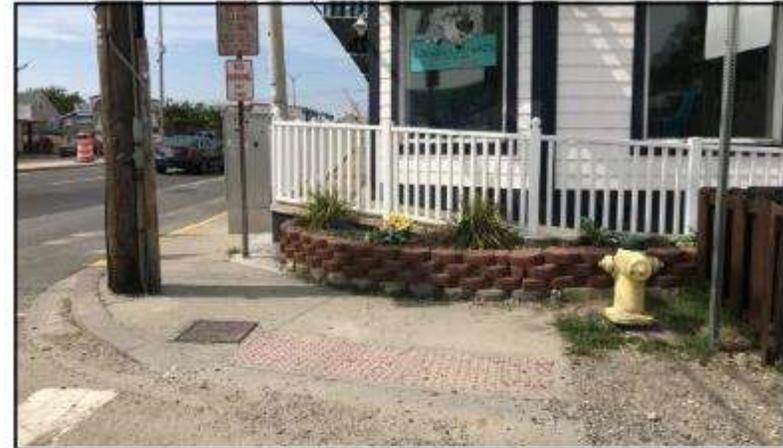
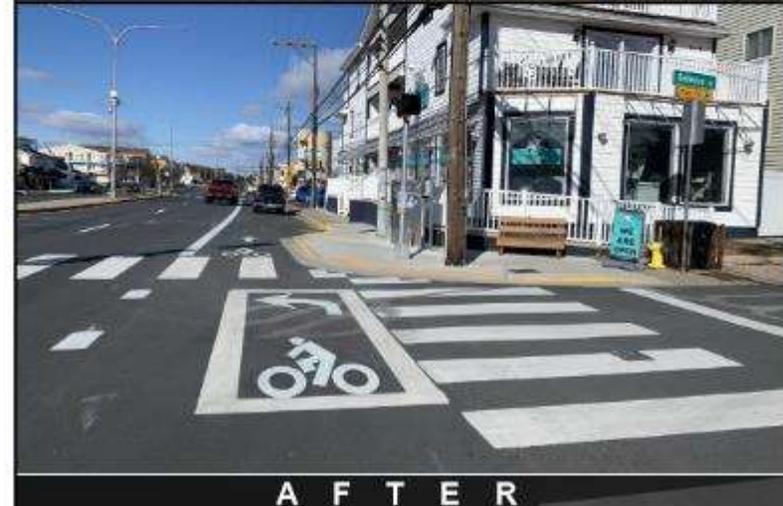
Curb Bumpouts

B E F O R E

A F T E R

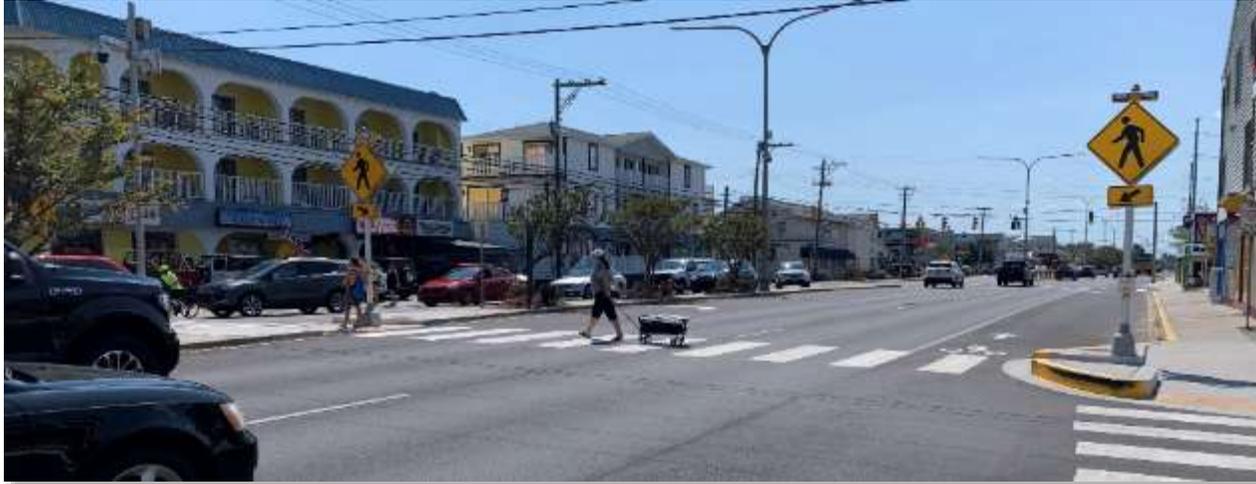
RRFB Locations – SR 1, Town of Dewey Beach

★ RRFB at Existing Crosswalk (8)

- SR 1 @ Van Dyke Ave
- SR 1 @ Rodney Ave
- SR 1 @ McKinley Ave
- SR 1 @ Dagsworthy Ave
- SR 1 @ New Orleans St
- SR 1 @ Swedes St
- SR 1 @ Clayton St
- SR 1 @ St. Louis St

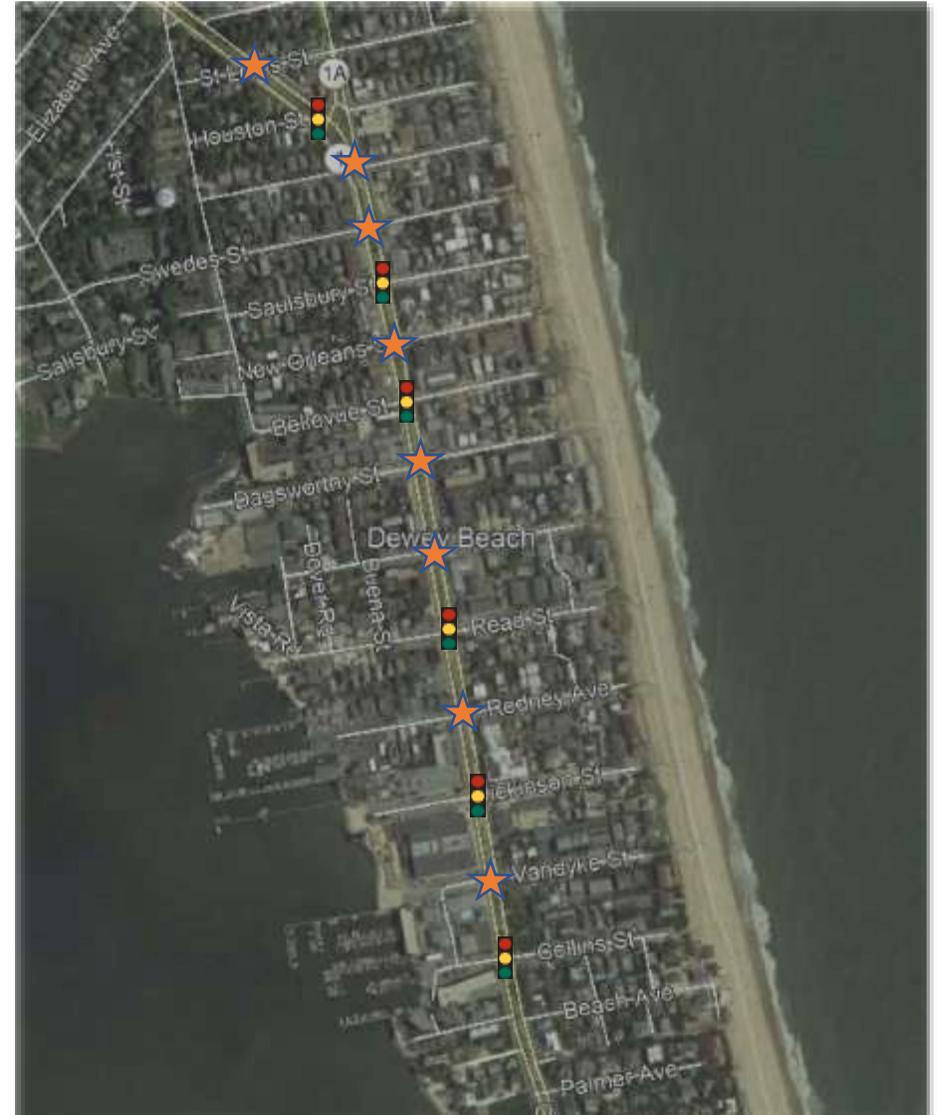
Existing Signalized Crosswalk (6)

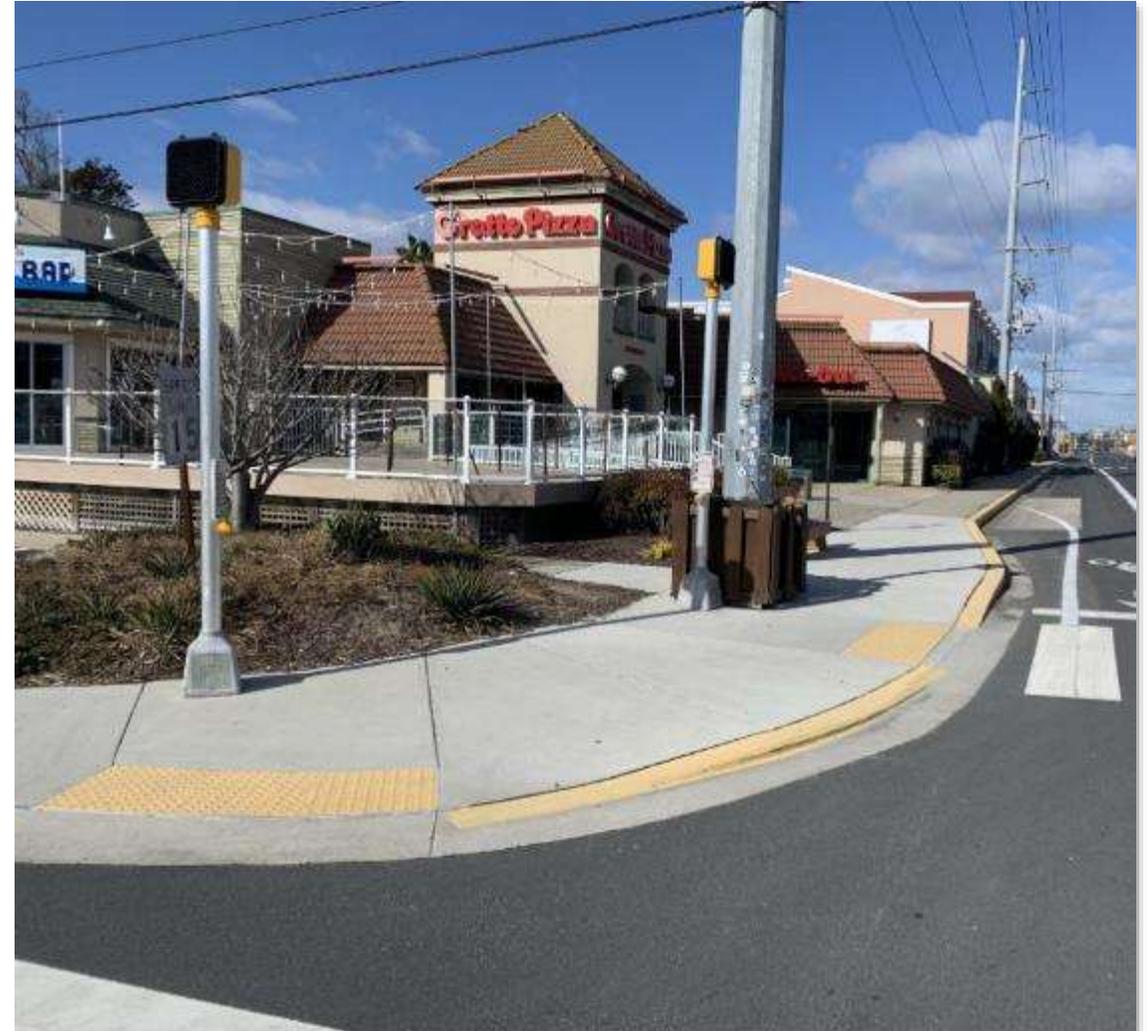
Pedestrian Upgrades at Traffic Signals:

- New painted crosswalks on side streets
- New ADA-compliant pedestrian signals located at level landing areas
- Reconstruction of non-compliant curb ramps
- Removal of outdated/non-compliant infrastructure (i.e., non-countdown pedestrian signal heads)

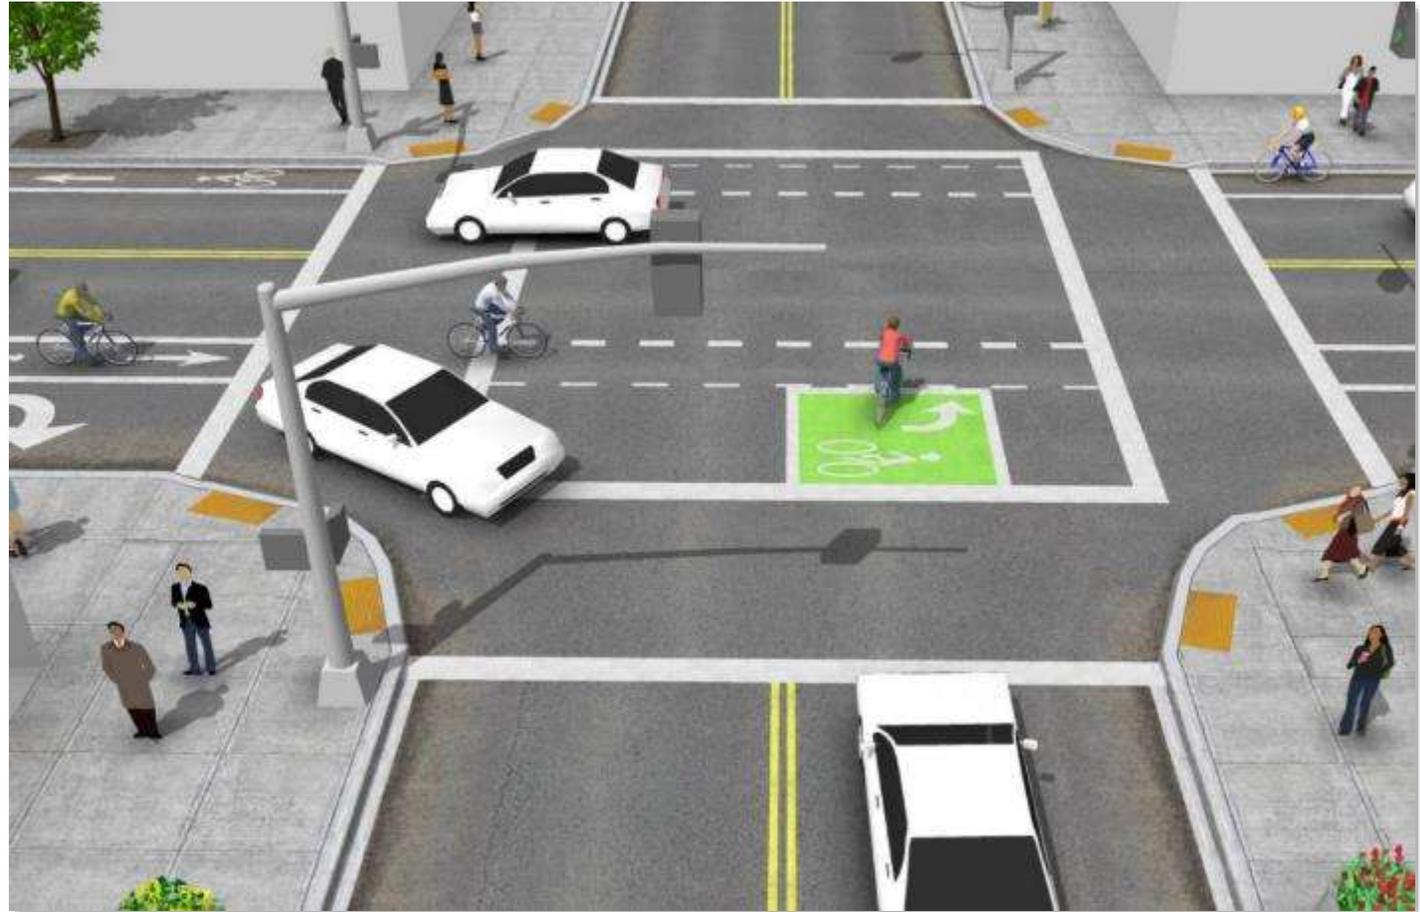
- Two-stage left-turn bike boxes
 - Delaware's first ever application
 - FHWA interim approval issued 2017
 - Allows cyclists to safely make a left turn from the right shoulder/bike lane without having to merge across through lanes and into a left-turn lane
 - Includes specialized in-pavement loop detectors for passive bicycle detection to call the side street phase

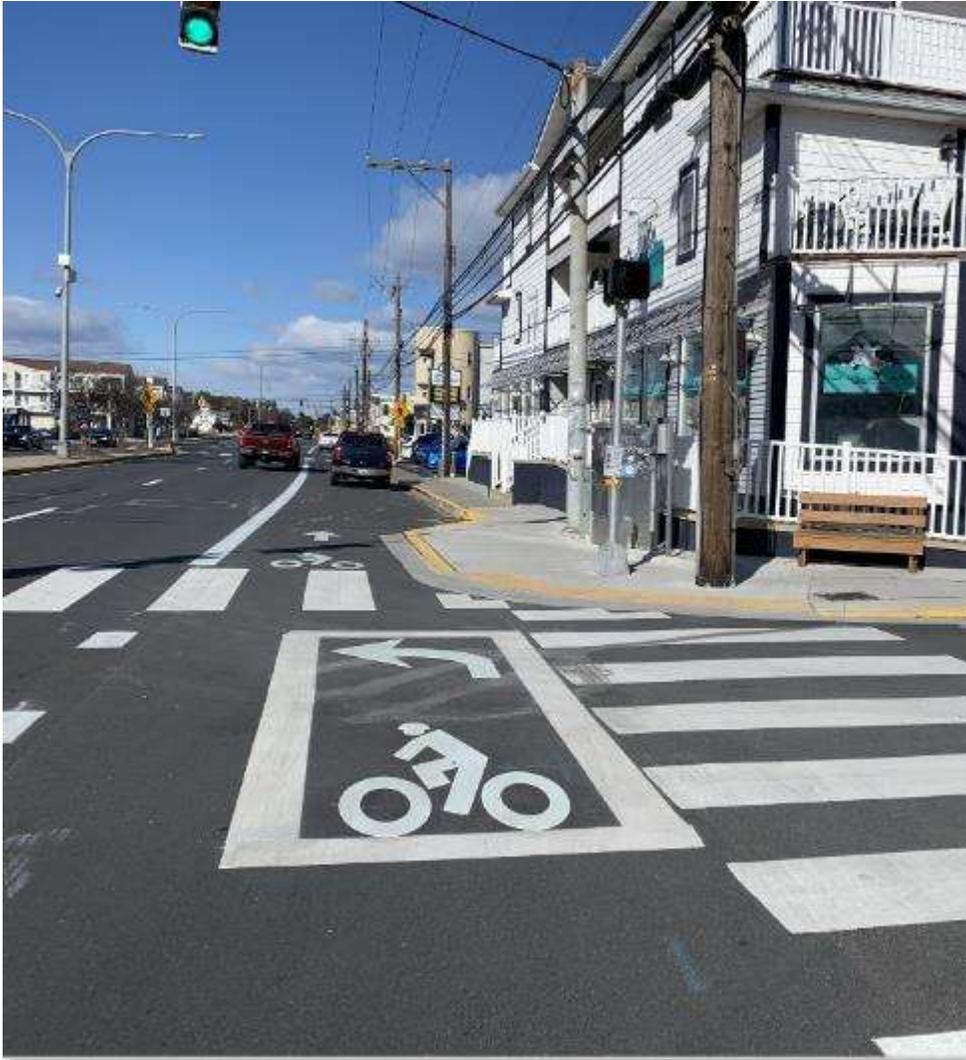
Left Turn Bike Box Design & Implementation Considerations:

- Agency must request and receive written approval from FHWA for use
- 3'x10' recommended minimum size
- Right turns on red shall be prohibited for side street traffic
- Shall contain passive bicycle detection if vehicular approach is actuated
- Green colored pavement and guide signing is optional (regulatory signing required if use is mandatory)
- Position to avoid conflicts with adjacent crosswalks and bicycle lane

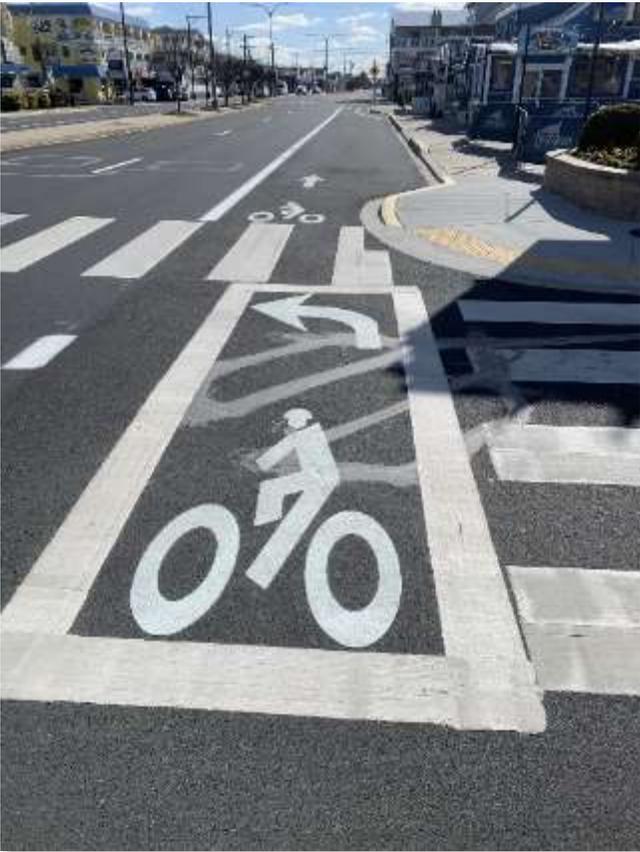
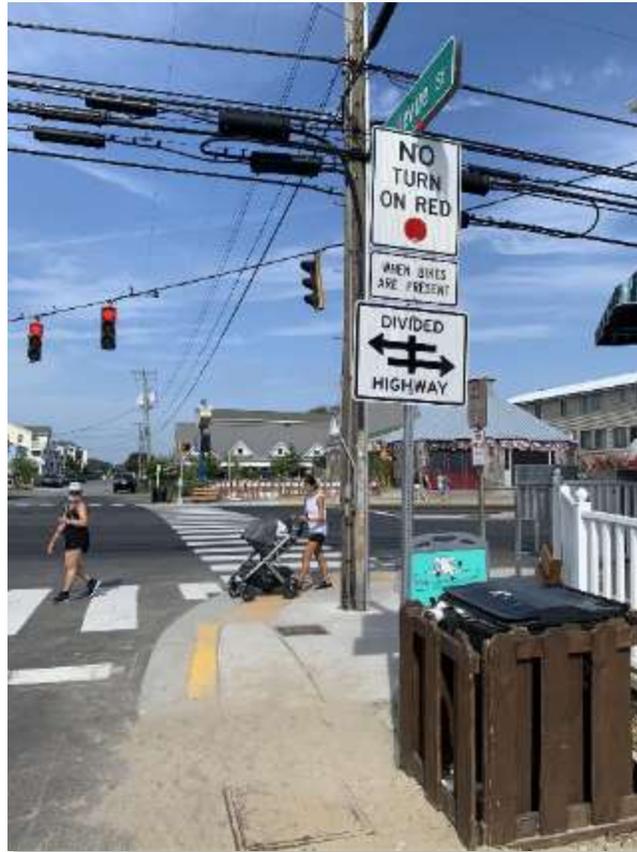
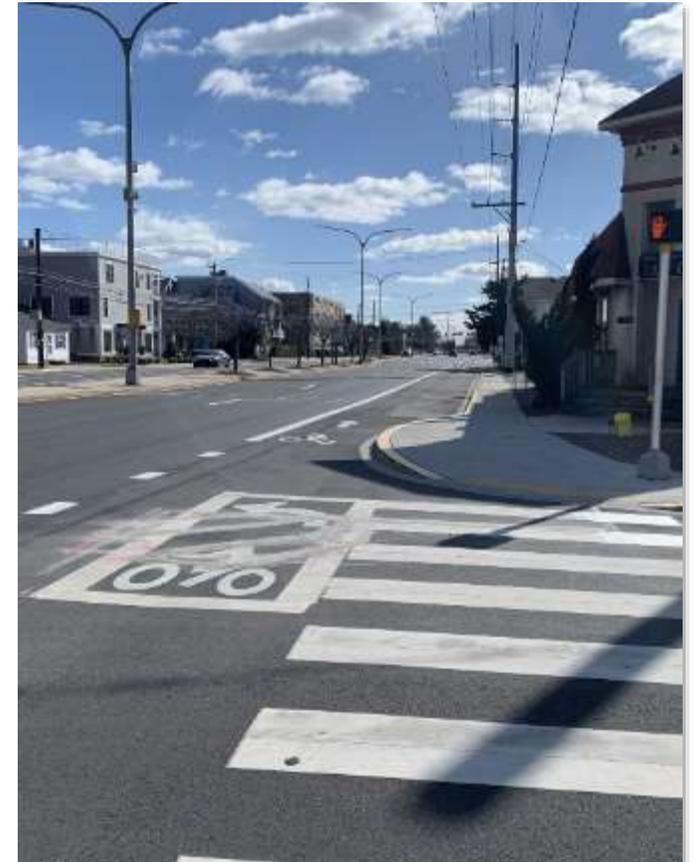
Bike Boxes - Additional Info:

- See National Association of City Transportation Officials (NACTO) Urban Bikeway Design Guide: <https://nacto.org/publication/urban-bikeway-design-guide/>
- FHWA Interim Approval 20 (IA-20) for the Optional Use of Two-Stage Bicycle Turn Boxes: https://mutcd.fhwa.dot.gov/res-interim_approvals.htm

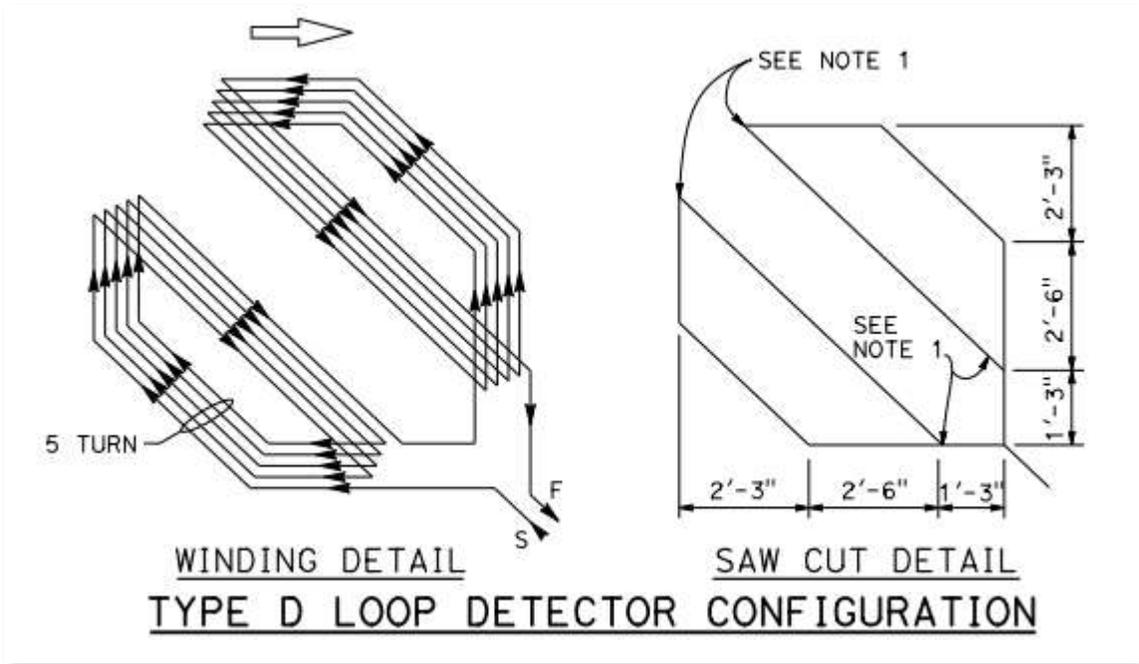
“D” Loop Bicycle Detector developed by CalTrans

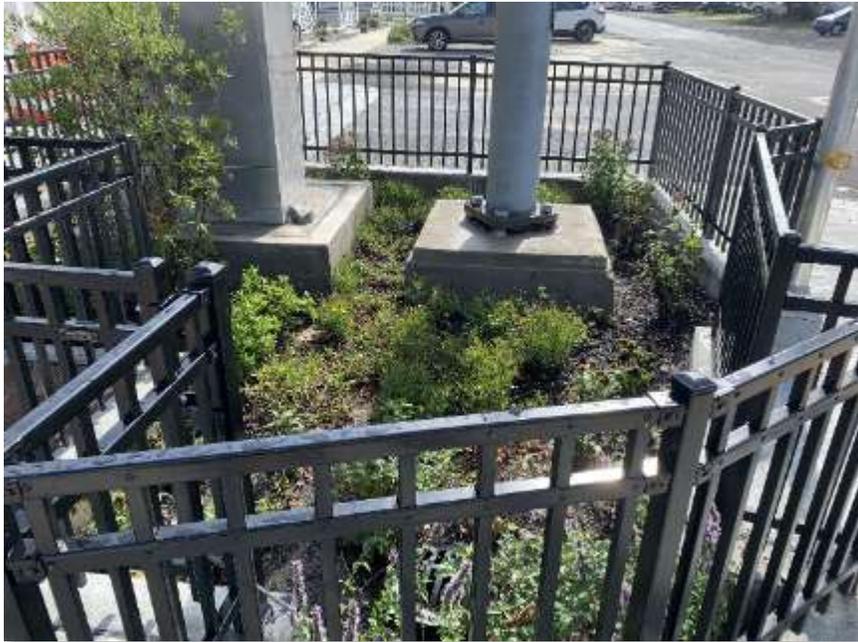
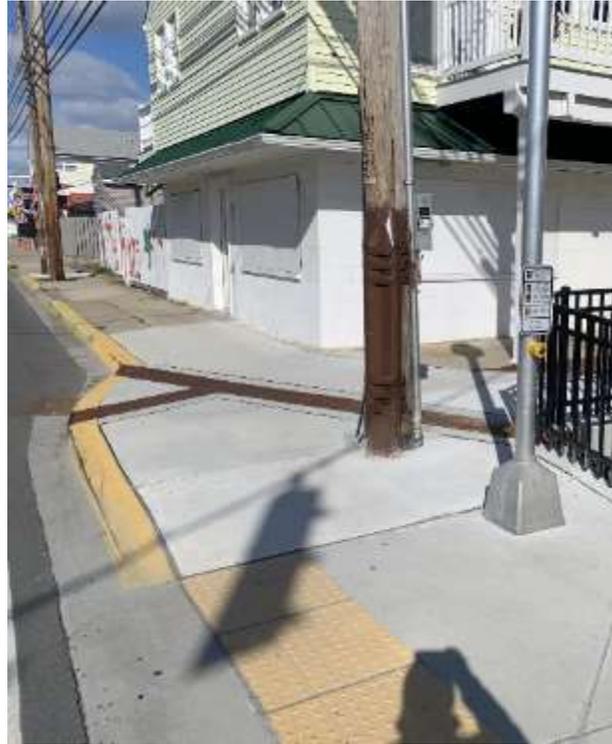
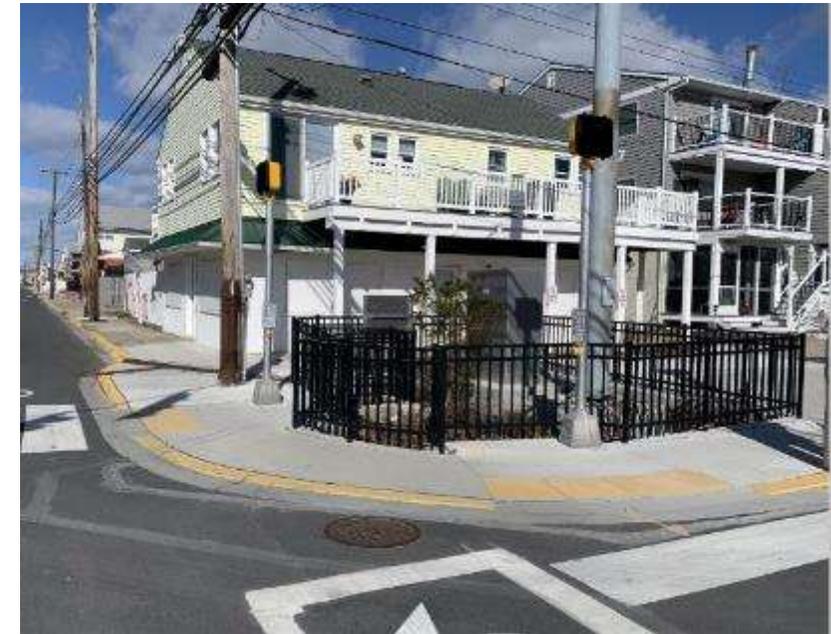
“Green” Stormwater Management Improvements:

- Inter-agency coordination with Delaware Center for Inland Bays to include a pilot bio-retention area to reduce storm runoff into the Rehoboth Bay

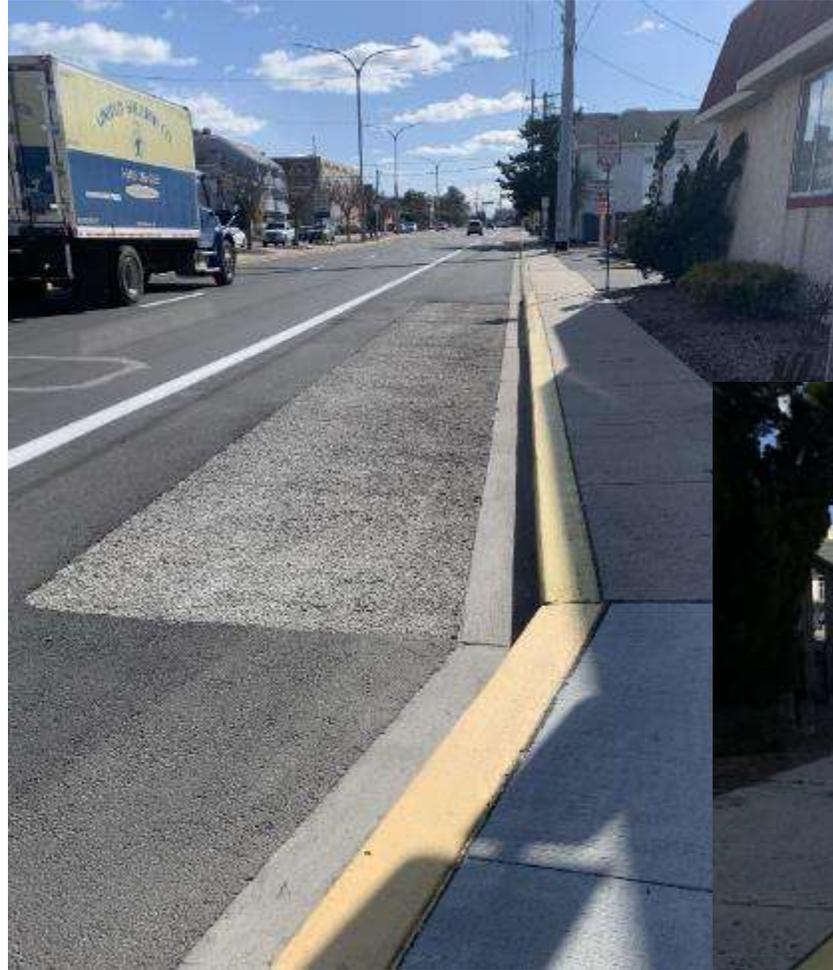
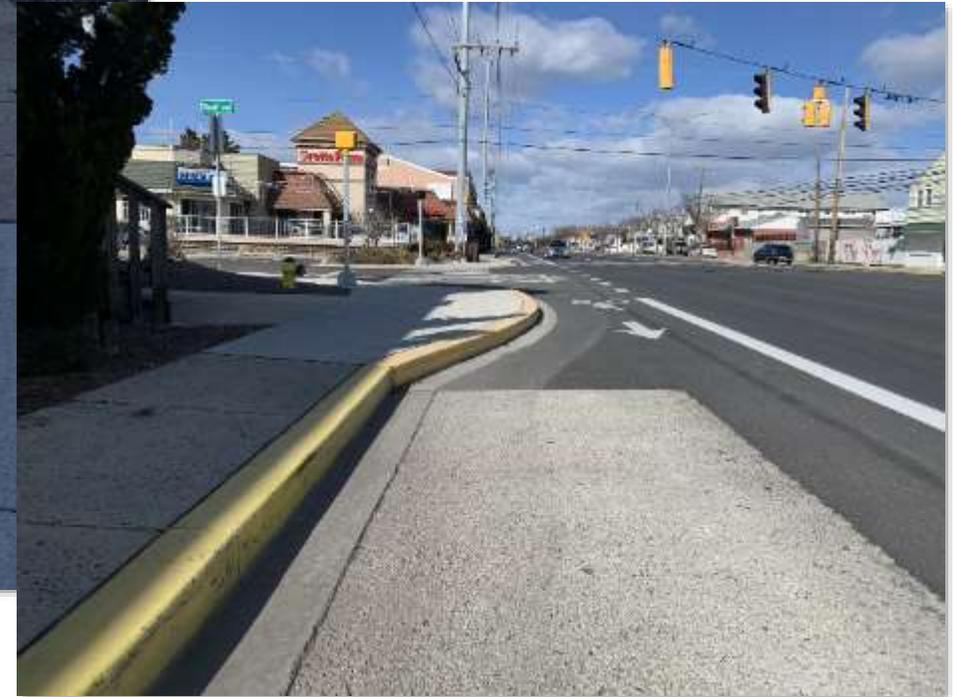
“Green” Stormwater Management Improvements:

- Installation of permeable concrete pavement along select areas of shoulder with historical drainage concerns
- Vacuum truck is used to clean sand and other debris to maintain porosity

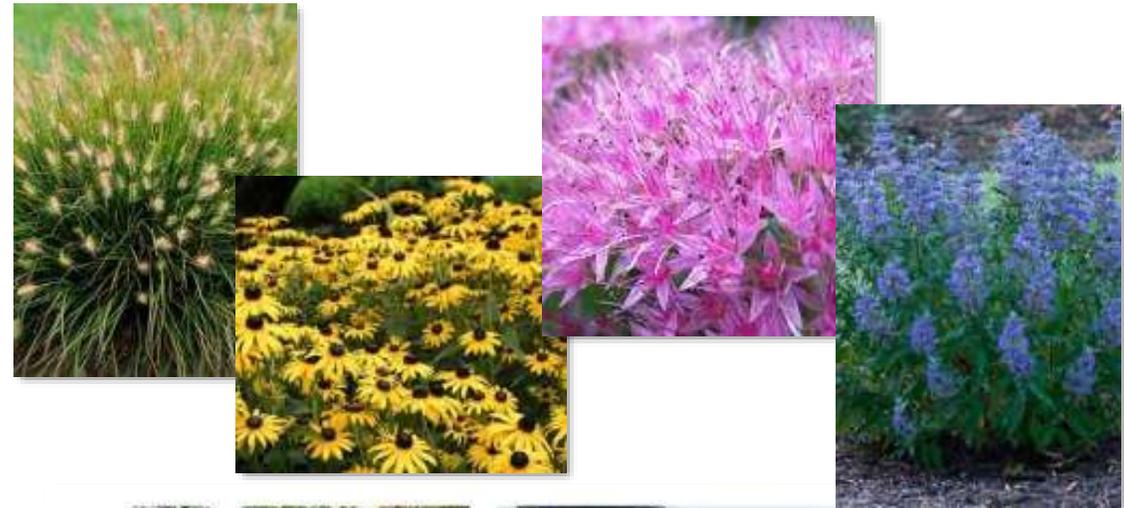
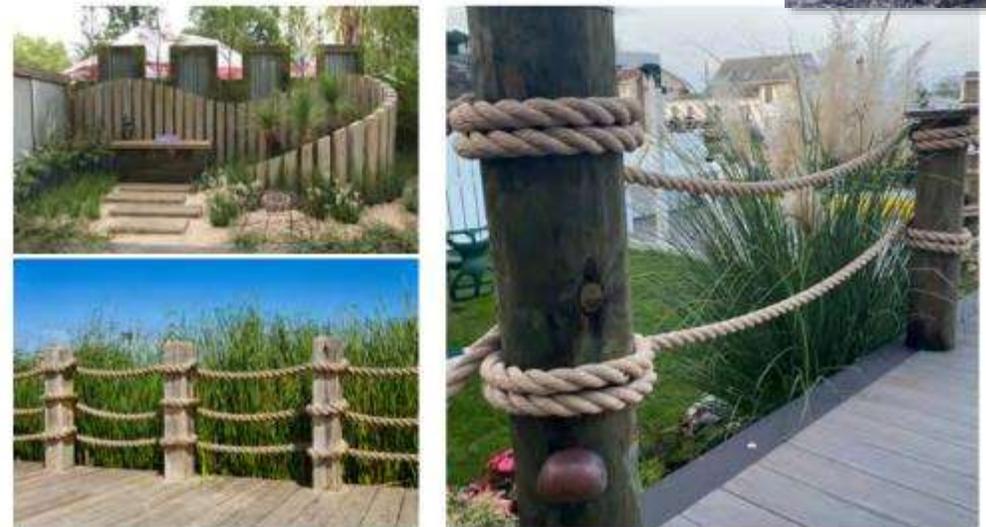
Inspiration Photos

Next Up for Dewey Beach – Median Pedestrian Barrier Coming this Fall/Winter

- Intended to “funnel” pedestrians to crosswalks and deter mid-block crossings
- Nautical post-and-rope theme
- Removal of existing concrete and new low-level landscaping and mulch
- Installation of 3 twin arm light poles in the SR 1 median from Houston Street to Bayard Ave
- Town Agreement → Town to own and maintain barrier system, landscaping, and additional lighting

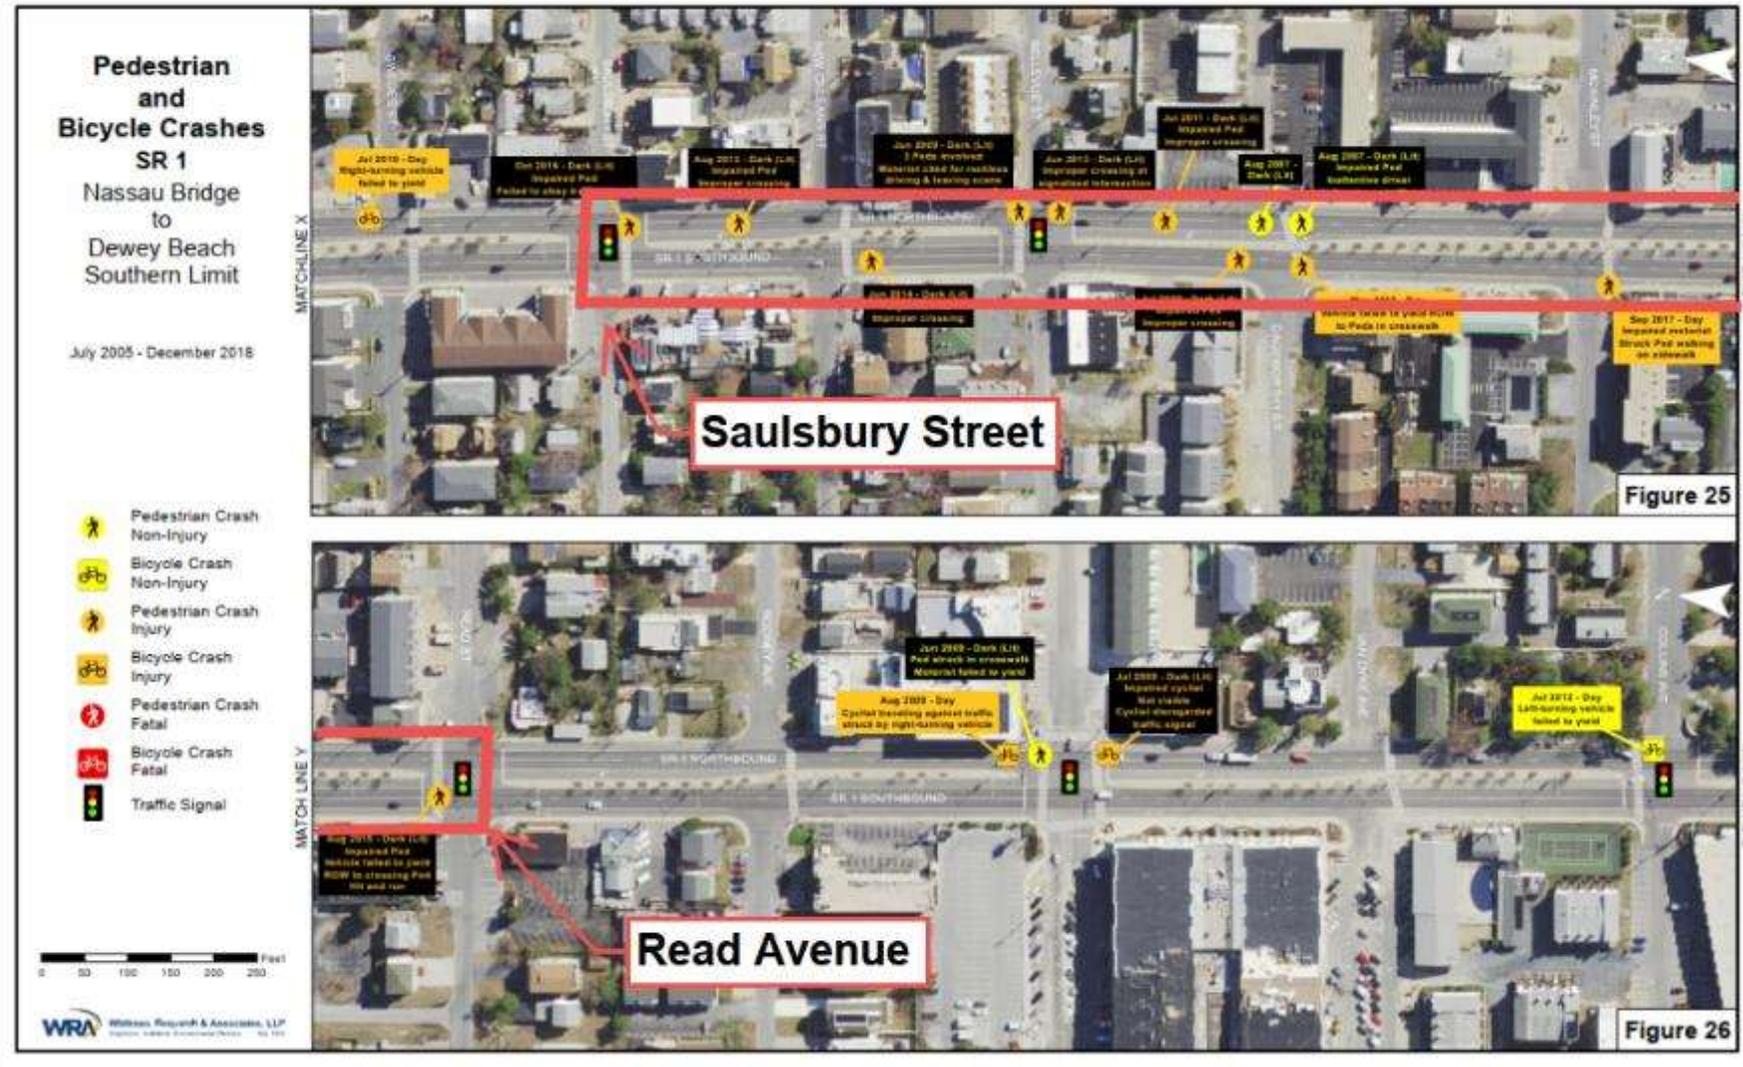
“Pilot” Median Barrier Project Limits – Saulsbury Street to Read Avenue

- Funded by DeIDOT Traffic with Town and local legislator contributions
- Limits based on historical pedestrian / bicycle crash clusters and adjacent land use
- ~1,500 linear feet
- Future capital or town project could extend barrier system

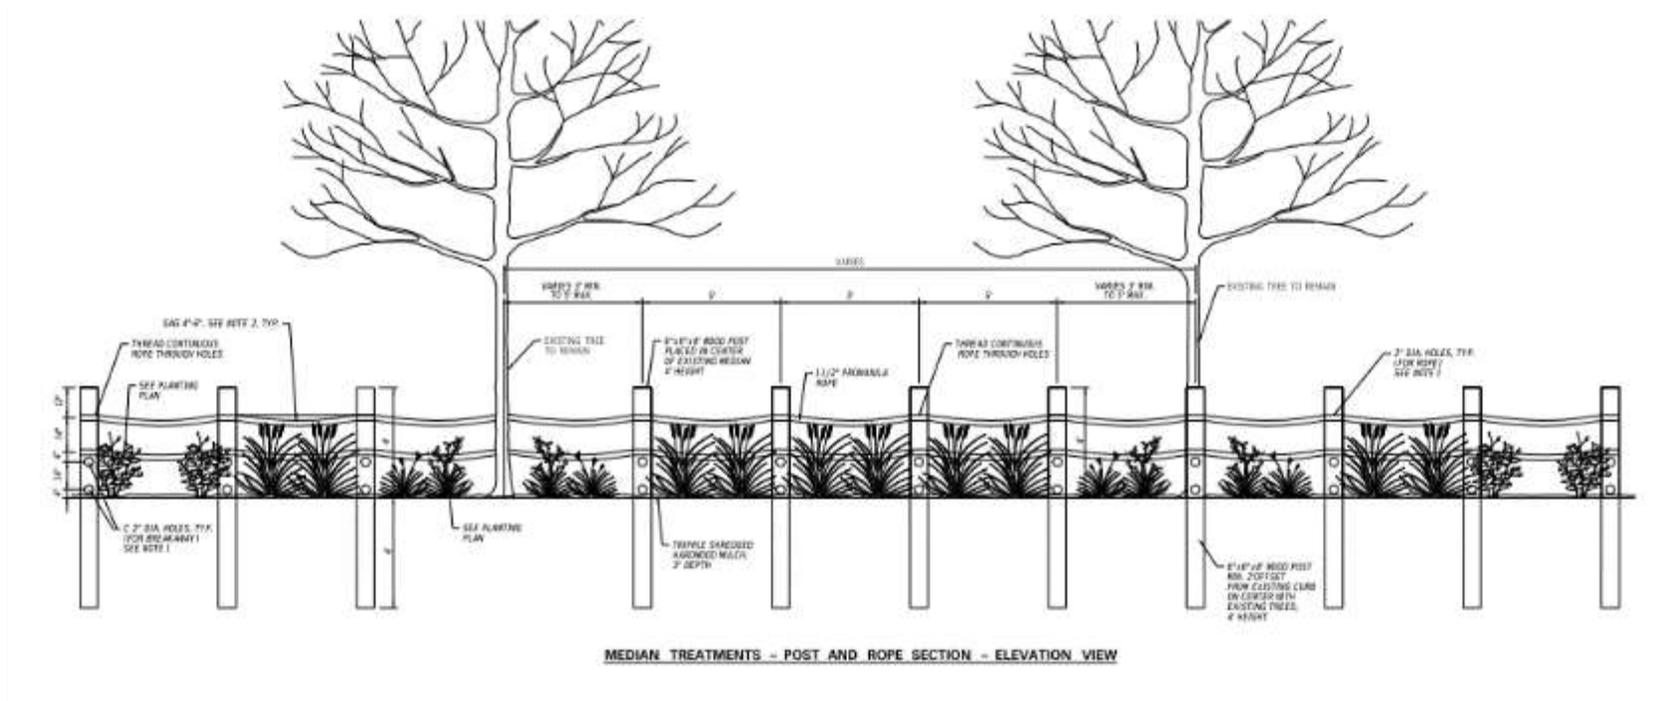
“Pilot” Median Barrier Project

- Similar to Florida DOT developmental standard detail
- Utilizes wood posts with holes drilled perpendicular to the direction of travel for breakaway effect
- System is not crash tested, but individual wood posts are NCHRP 350 approved
- Pedestrian safety benefits outweigh rare potential for roadway departure crash (curb, low speeds, urban setting)
